San Clemente Green

Citizens for a Sustainable Future

I'm here to bring urgent attention to
a serious public safety concern:
visible damage to nuclear waste
canisters at San Onofre,
just outside our city.

We obtained photos of canister #72, that in 2019 showed significant damage in less than two years.

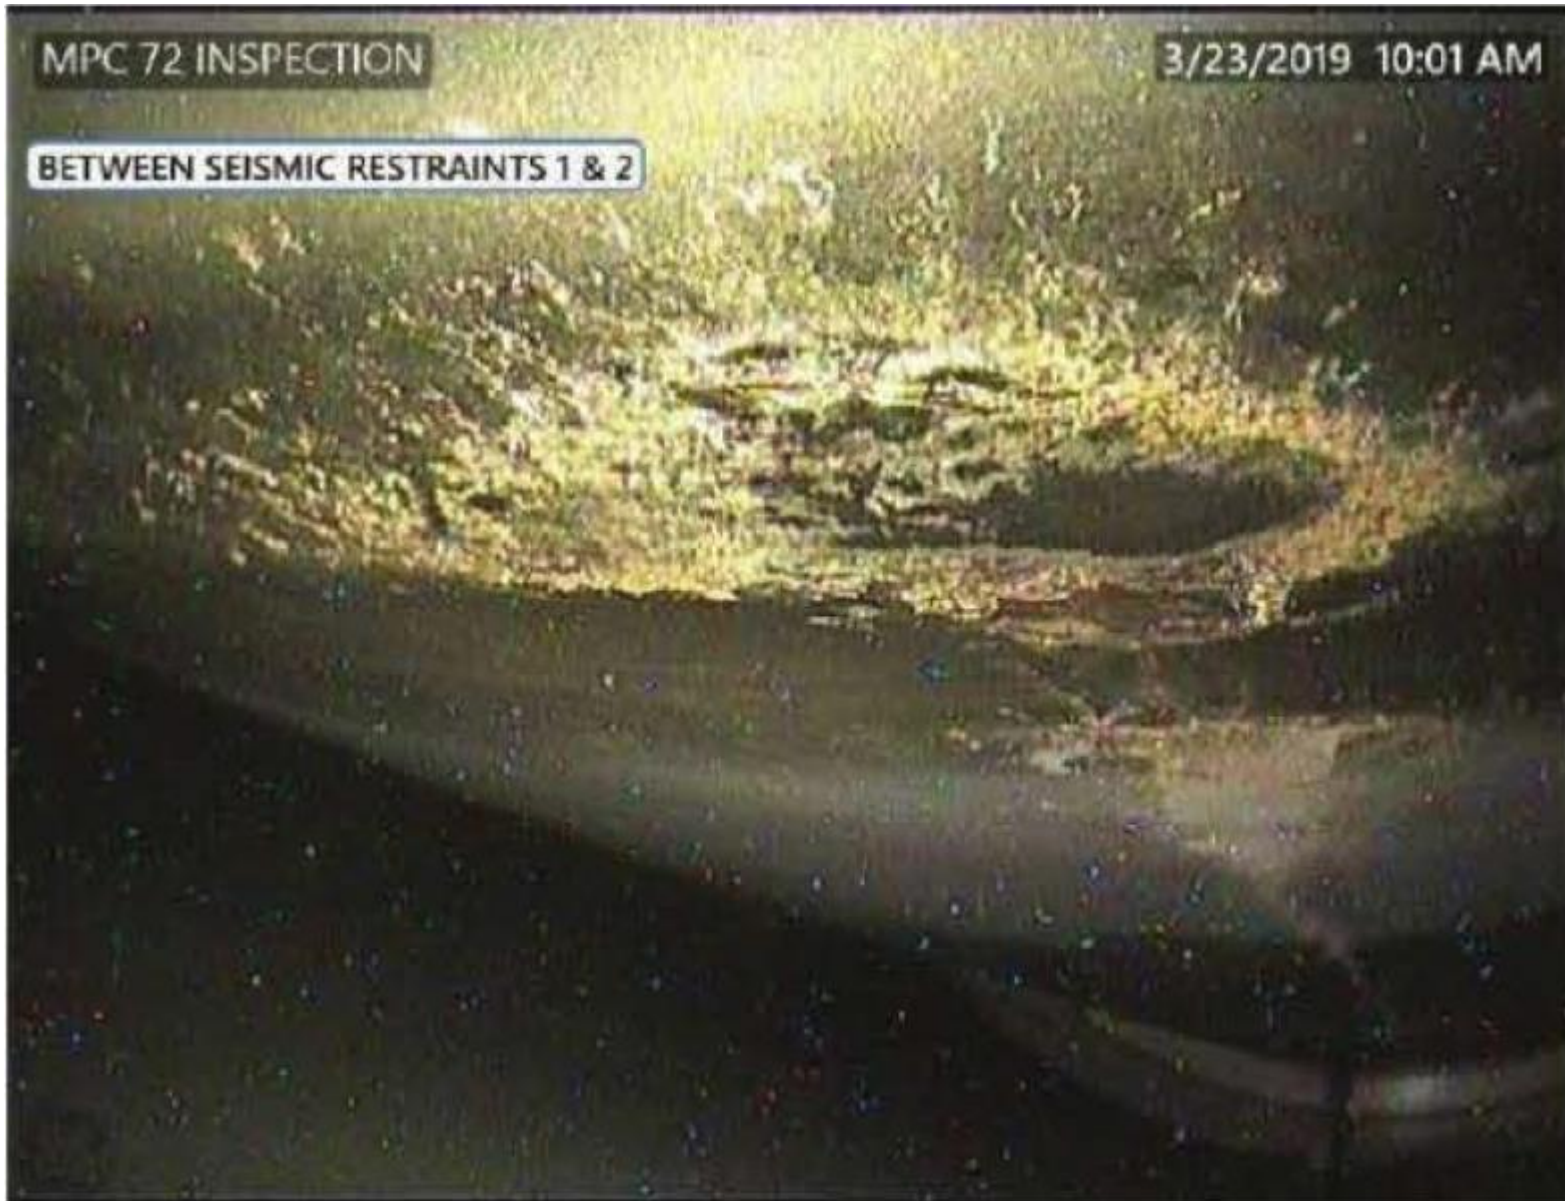
Evidence of corrosion on canister #72 in 2019. This can lead to "Stress Corrosion Cracking" which is well known by the industry.

These 2019 inspection photos show clear evidence of corrosion and gouging on canister #72. Industry experts confirm that these are well-known warning signs for stress corrosion cracking—one of the leading causes of canister failure.

We requested that it be re-examined to see how much worse it has become in the past 5 or 6 years.

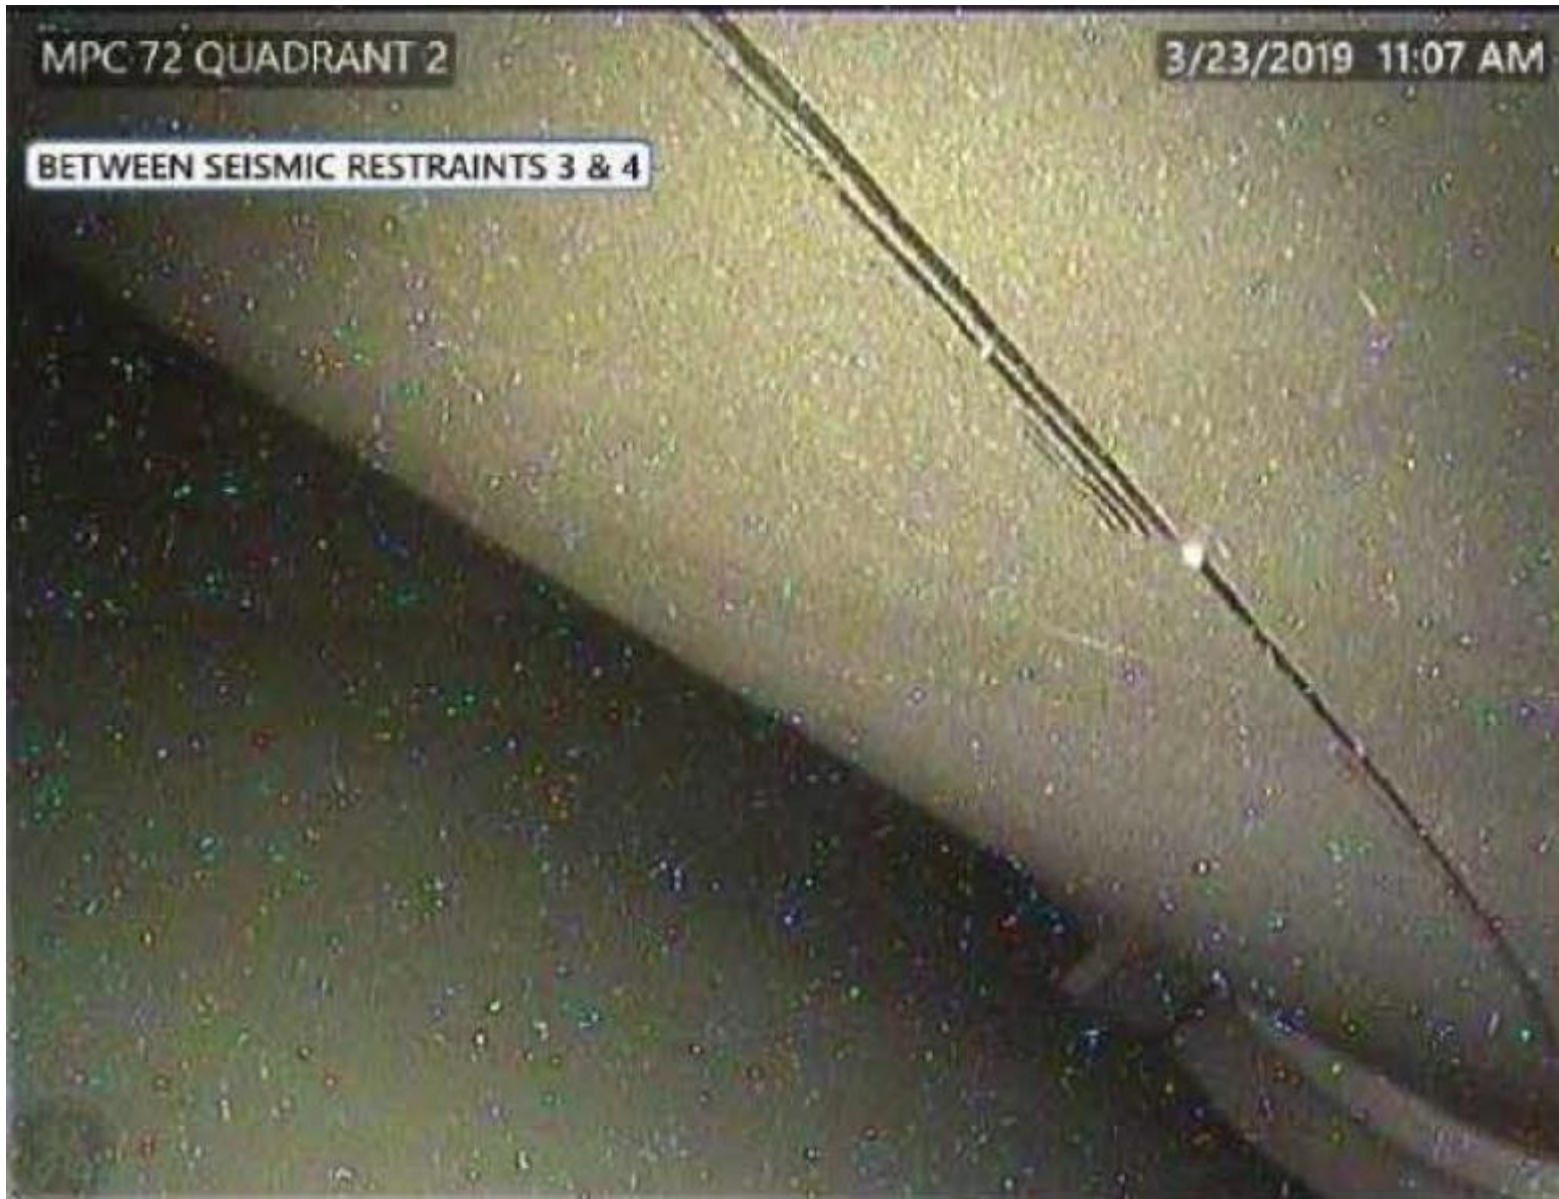
Evidence of gouging on canister #72 in 2019. This can also lead to canister failure.

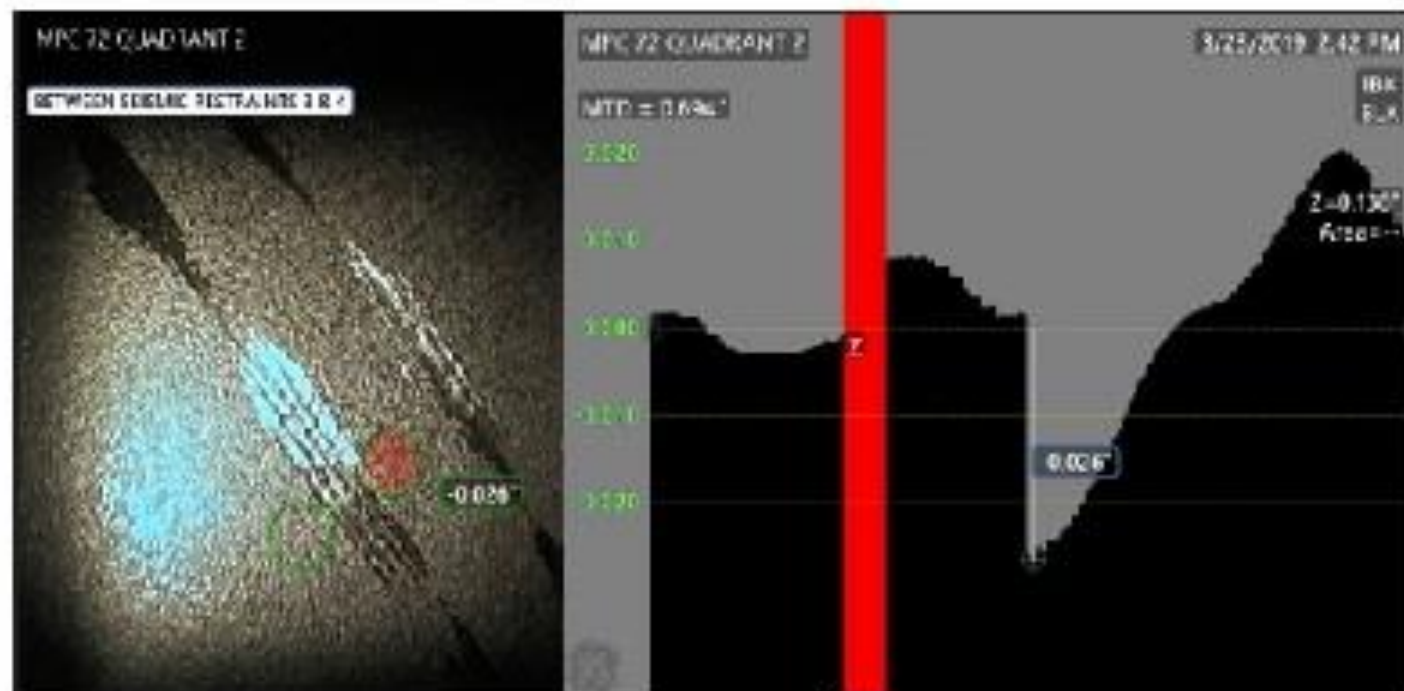
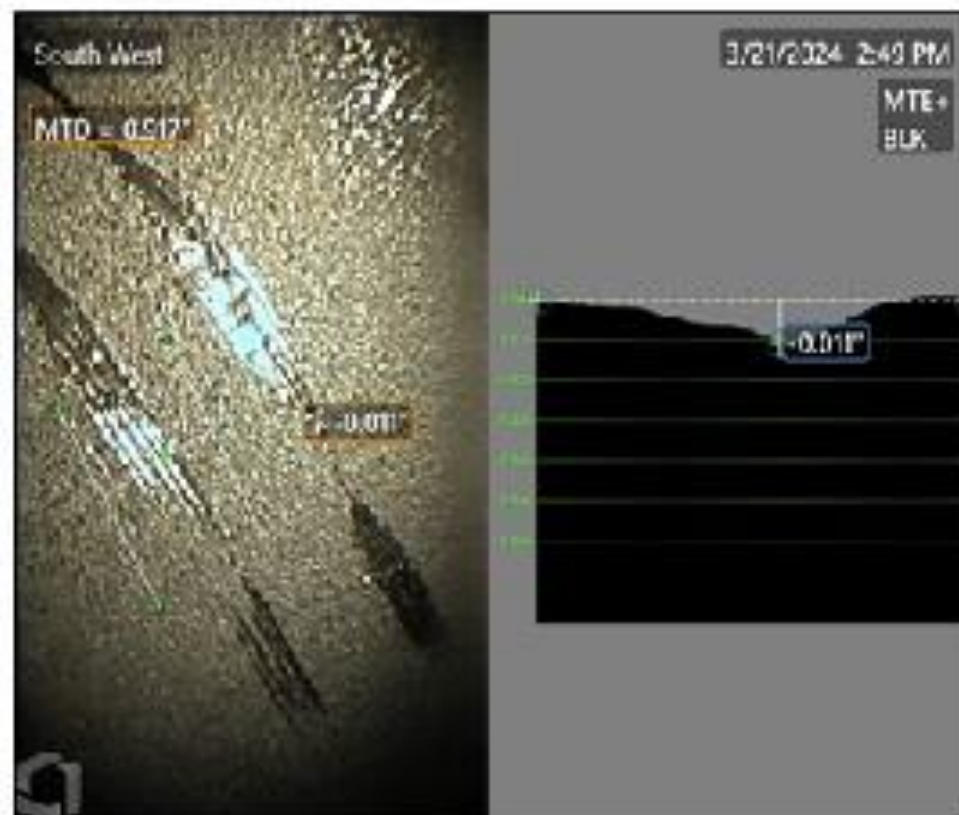
2019 (left) vs. 2024 (right) Depth Measurements

Instead of showing us the same damaged areas for comparison, SCE shows some minor damage to #72 and used that to claim “no need for intervention at this time”.

- Original characterization in 2019. Notice the red dot on left image and vertical straight line, which indicates a possible erroneous reading..
- Remeasurement in 2024.

“That picture of the long scratch on 72 is not trying to measure depth. The blotch on 72 is from a paint defect on the transfer cask (used to get waste out of spent fuel pools and into dry storage canisters). That allowed iron oxide to affix to 72.”

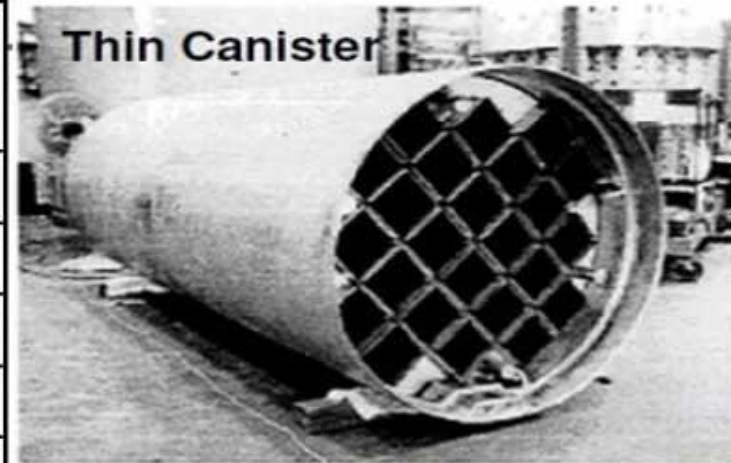
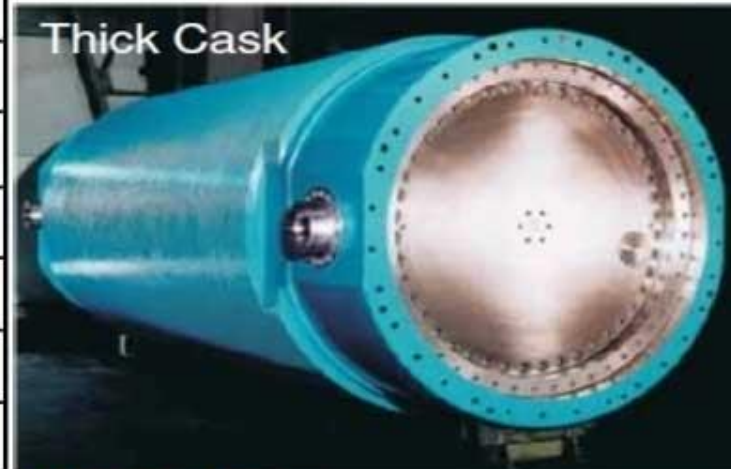
CASTOR® - Type V/19 cask

Ten reasons to use thick nuclear waste storage casks

| Safety Features | Thin canisters | Thick casks |
|---|---|---|
| 1. Thick walls | 1/2" - 5/8" | 10" - 19.75" |
